Building Inspection Report

419 Kathryn Place, Santa Fe, NM 87501

Inspection Date: 12/11/14

Report Number: 10021

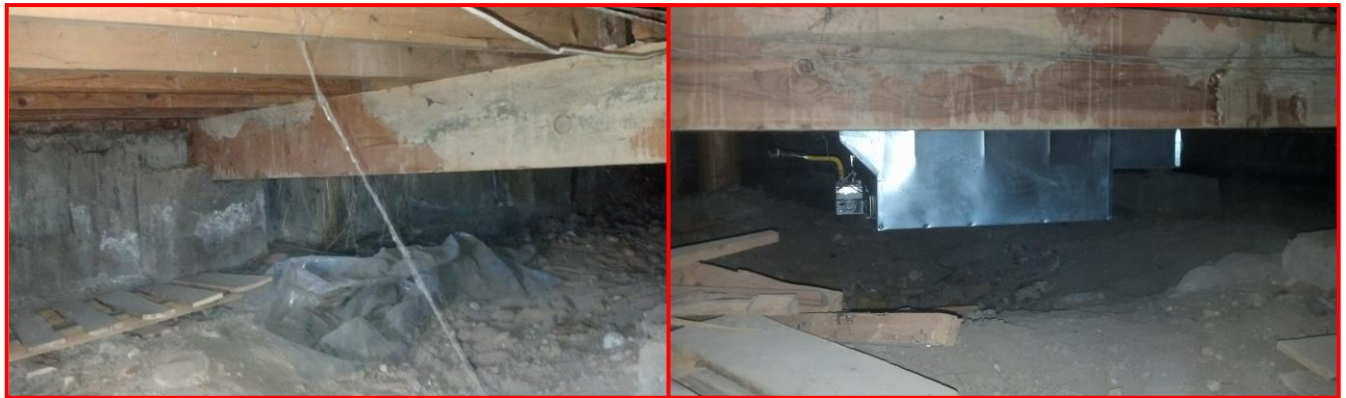
1. Crawl space is a little messy and needs a clean-up to prevent rodent infestation and nesting.
2. Some of the foundation vents need to have the insect screens repaired or replaced.

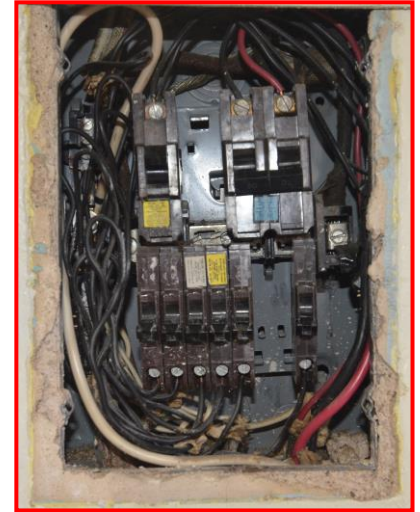
1. Inside of the Breaker Panel has missing cover plates over some of the breakers. This is a **HAZARDOUS** situation and needs immediate attention. Consult with a licensed electrician.
2. Most of the receptacles are not properly grounded and/or missing the bare ground wire due to earlier codes.
3. GFI devices have been "faked" wired to work but not protect.

1. The Main Panel for this house is out of date and substandard, being only rated to 40 Amps, which is far below the standards of a typical home that should have a service rating of a minimum of 100 Amps with a Main Disconnect. Recommend to contact a licensed electrician to straighten out this situation for peace of mind.
