Building Inspection Report

419 Kathryn Place, Santa Fe, NM 87501

Inspection Date: 12/11/14

Report Number: 10021

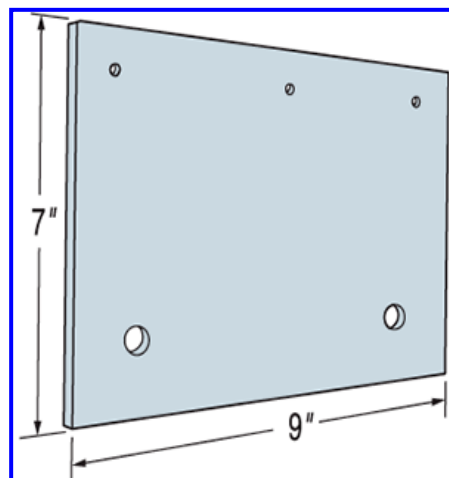
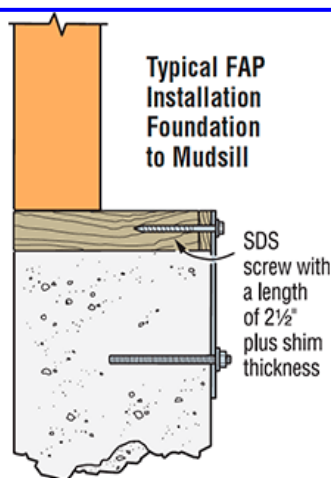
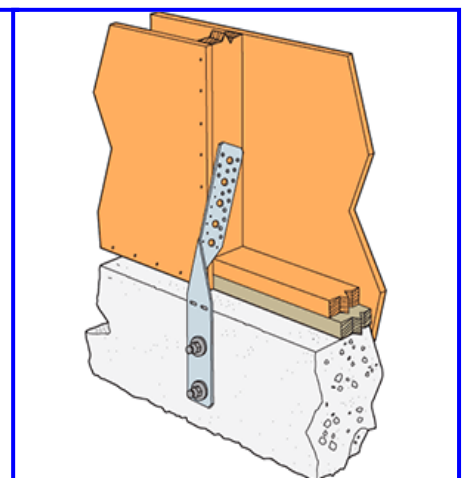
1. Exposed soils should be covered with a radiation shield, (plastic) to prevent exposure, especially if Radon levels prove to be too high.
2. The building plate (sill plate) is not anchored by anchor bolts as per UBC Seismic Codes. You can correct this situation in the future and bring this house up to the new earthquake standards if you like, but this is not required now. The method is to secure the joists to the sill plates @ 6'-0" on the bearing sides with Simpson Earthquake StrongTies that can be easily installed to retrofit this house to the new Seismic II Zone throughout the Rio Grande Valley in this region. Furthermore, I designed a variety of foundation anchors for Simpson in the San Francisco Bay Area in 1990, Seismic Retrofits, Inc.
